# Fergus and Judith Basin Counties Remaining Prospects

Final Report  
Abandoned Mine Reclamation Project

## FERGUS AND JUDITH BASIN COUNTIES REMAINING PROSPECTS ABANDONED MINE RECLAMATION PROJECT

Robert Peccia & Associates, Inc.  
Helena, MT

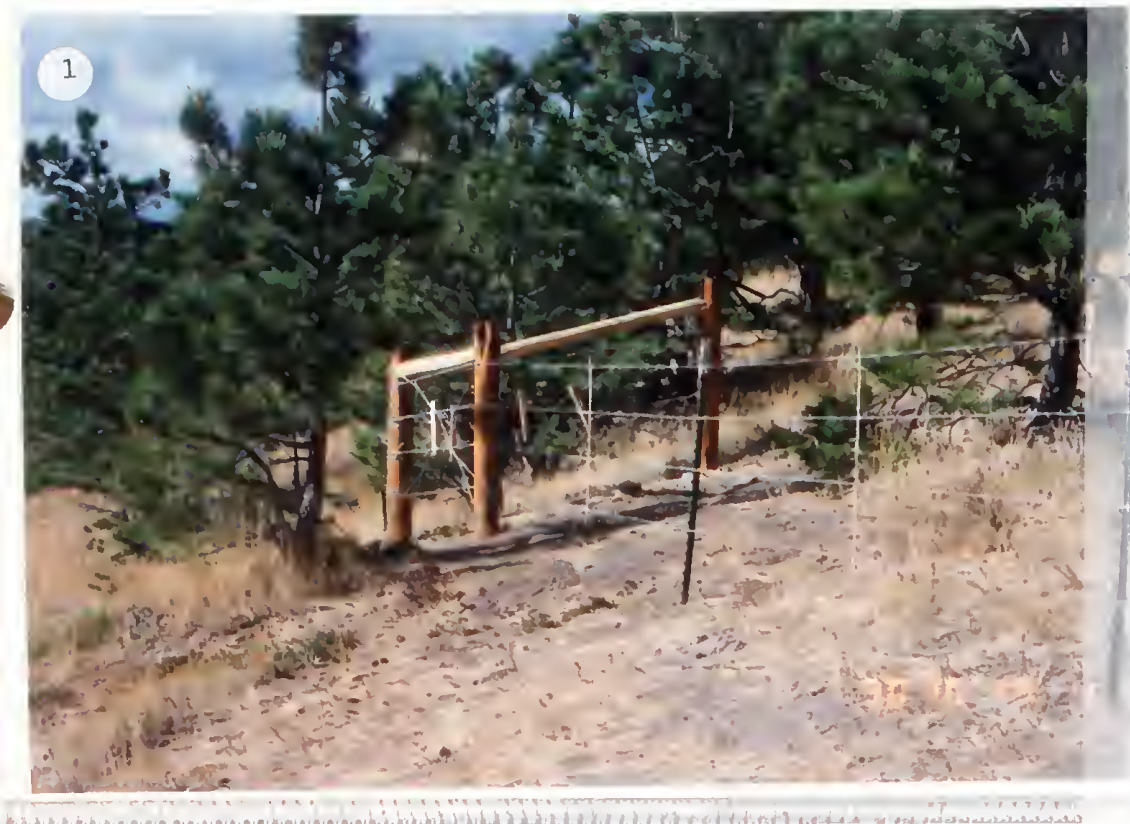
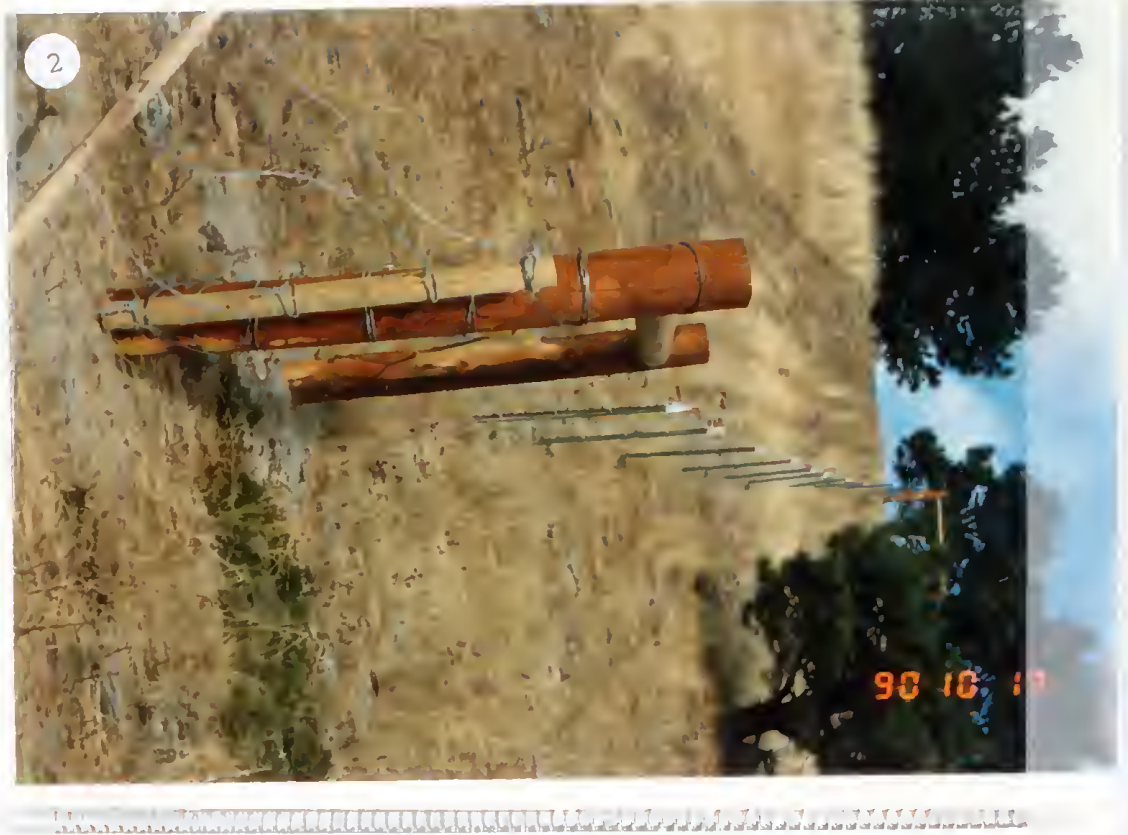
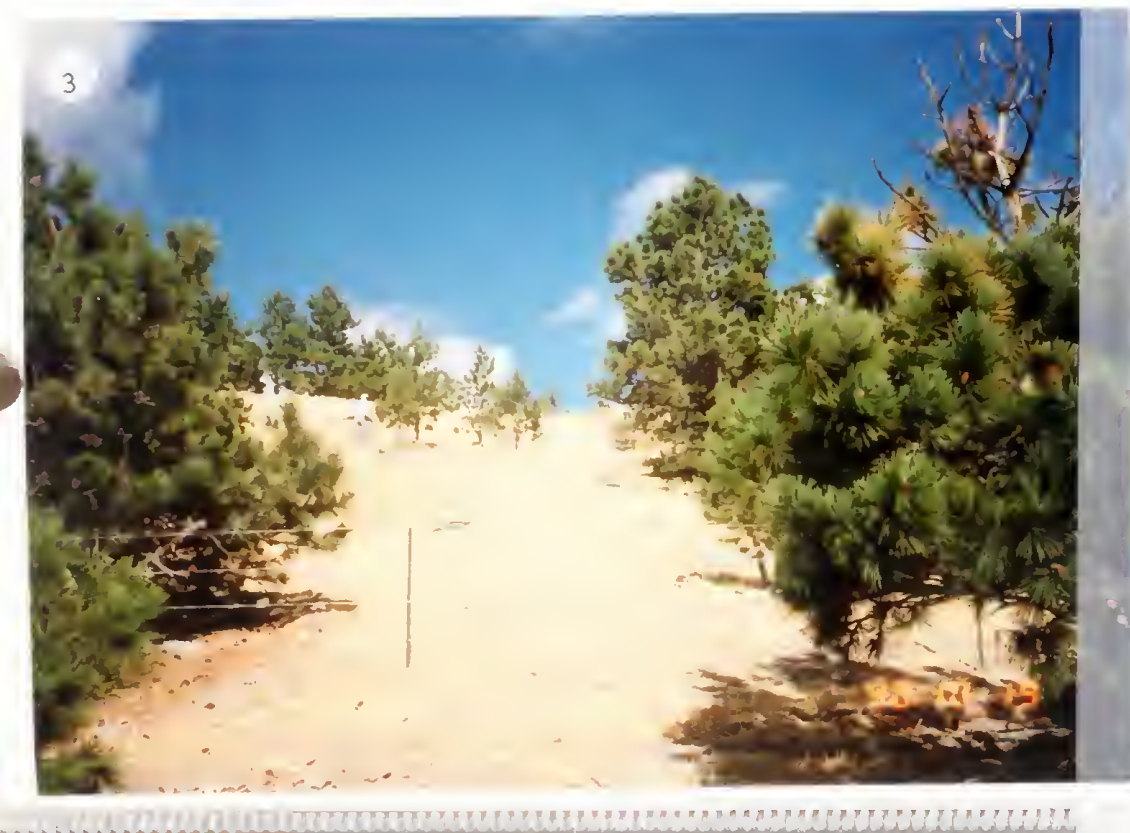
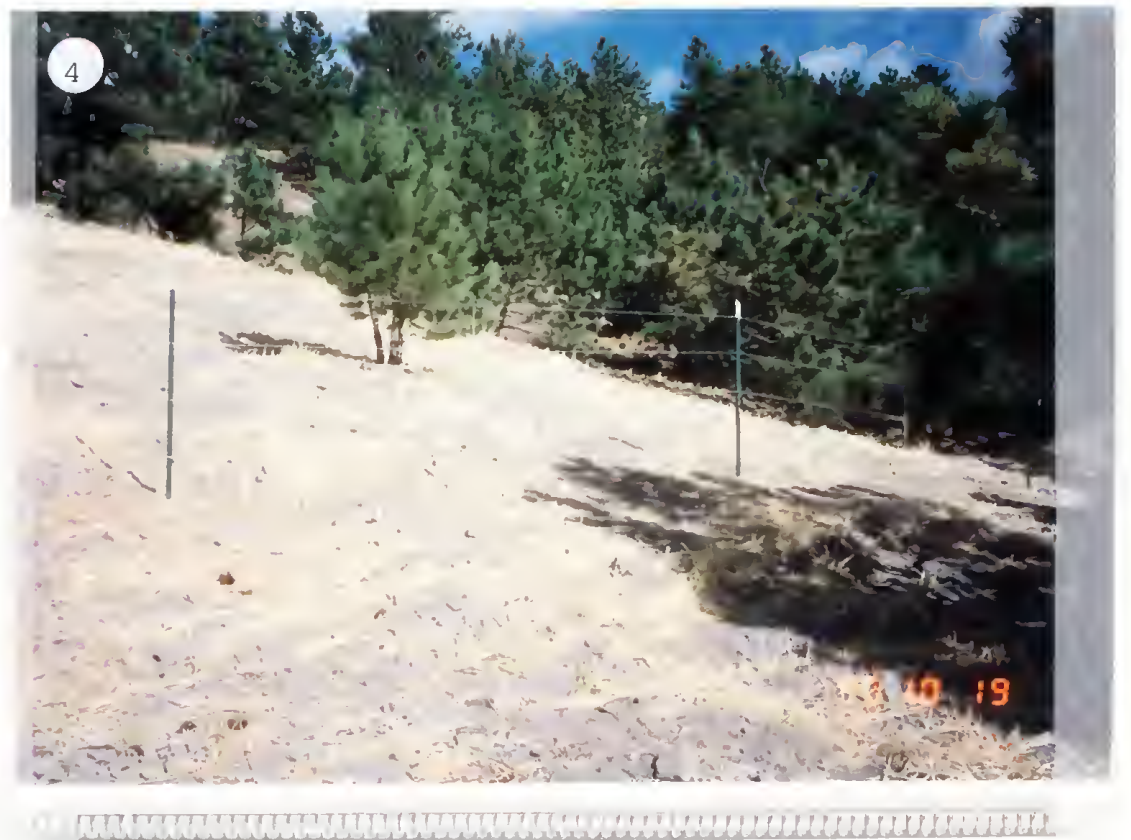
1. Ward Mine - Fence Construction
2. Ward Mine - Fence Construction
3. Ward Mine - During Seeding & Fertilizing
4. Ward Mine - Site After Reclamation
5. Ward Mine - Site After Reclamation

The contractor moved to the Ward Mine on 9/19/90. The adit at this site was found to be open during exploration. The opening was closed per Standard Drawing 410.01. Coversoil for this site was stockpiled from the area around the adit opening, but was not enough to provide the specified coverage so a borrow area at the top end of the site was designated. Lime was spread and incorporated at twice the rate as the previous sites per the plans. Incorporation was difficult due to the rocky nature of the site. The teeth of the Bobcat bucket had to be used to rip the site before disking could be accomplished. Some areas of the site were not incorporated to the specified depth due to the discovery of a sandstone outcrop running at a six inch depth near the top end of the site. Coversoil at this site was marginal, but due to the rocky nature will form a rock mulch and will not wash, or otherwise erode easily. Crimping of straw mulch at this site was attempted with the new crimping device that Mel had fabricated, but the final product was marginal due to the nature of the available coversoil. Fence work was being accomplished at the same time.

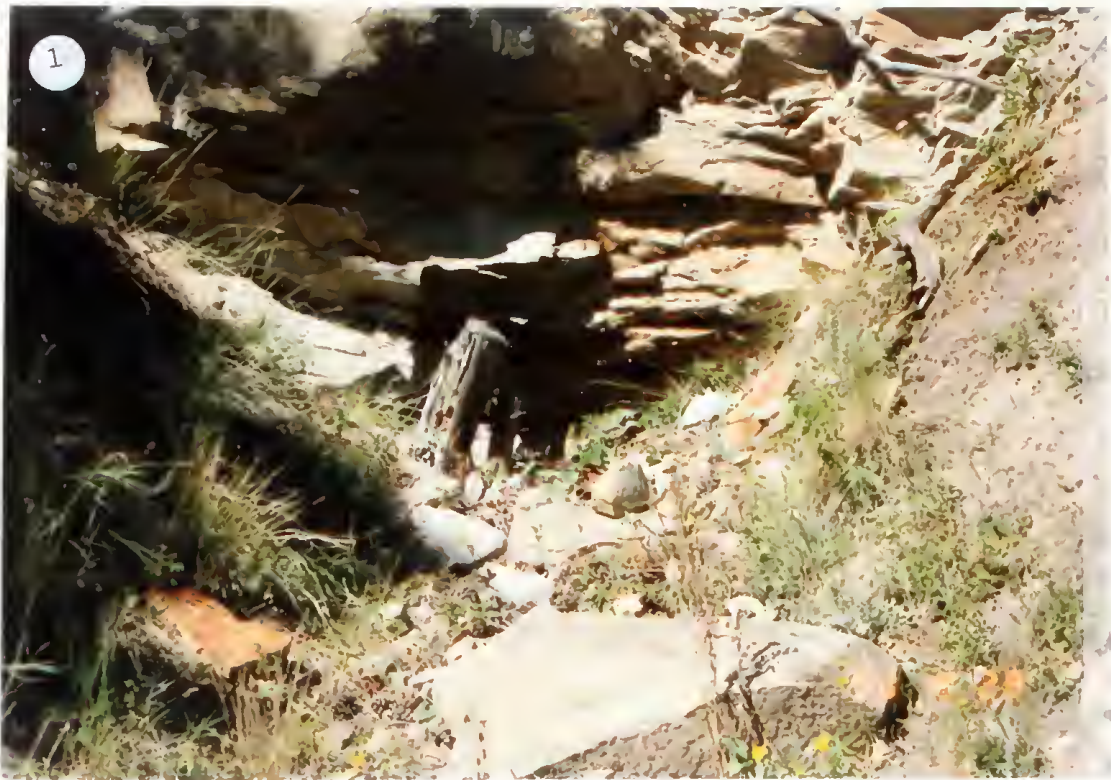
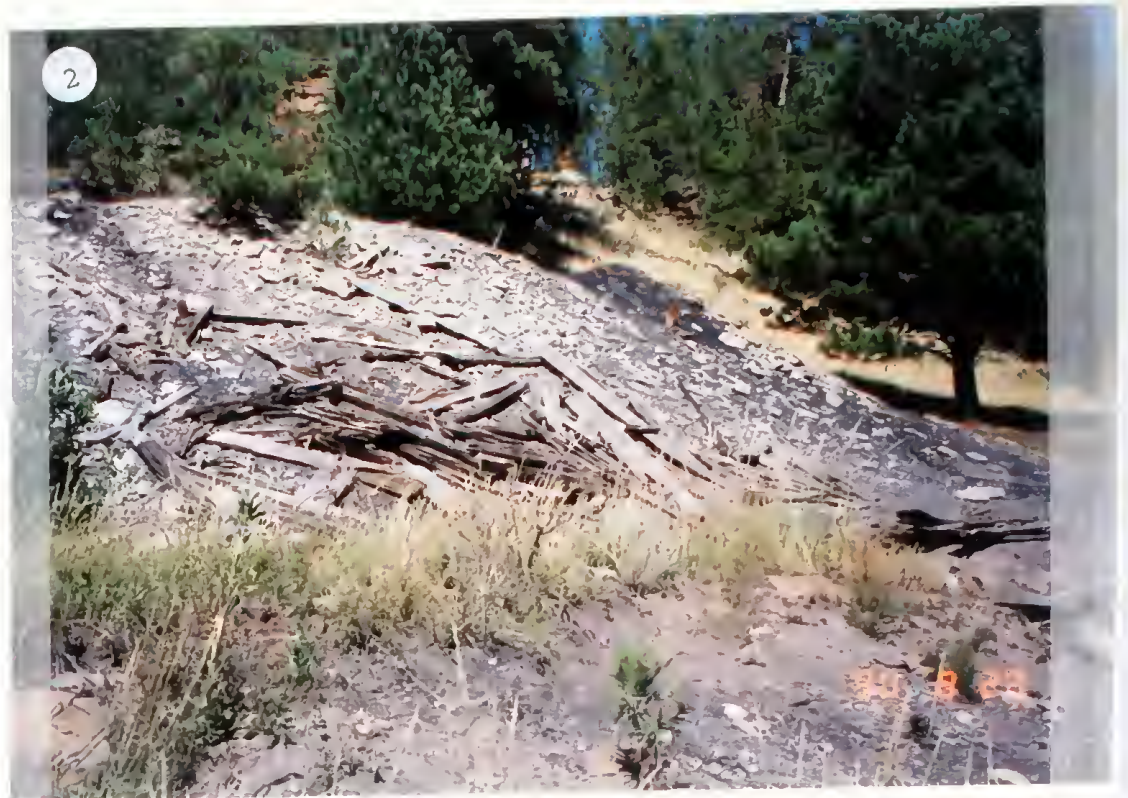
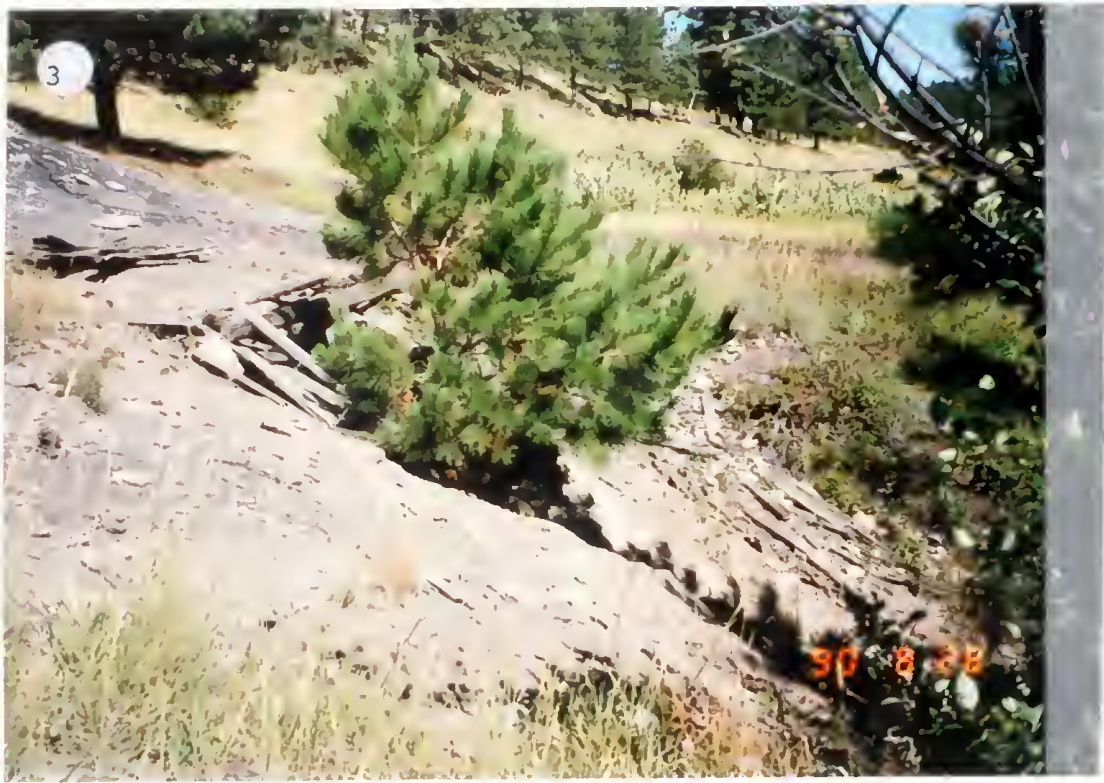
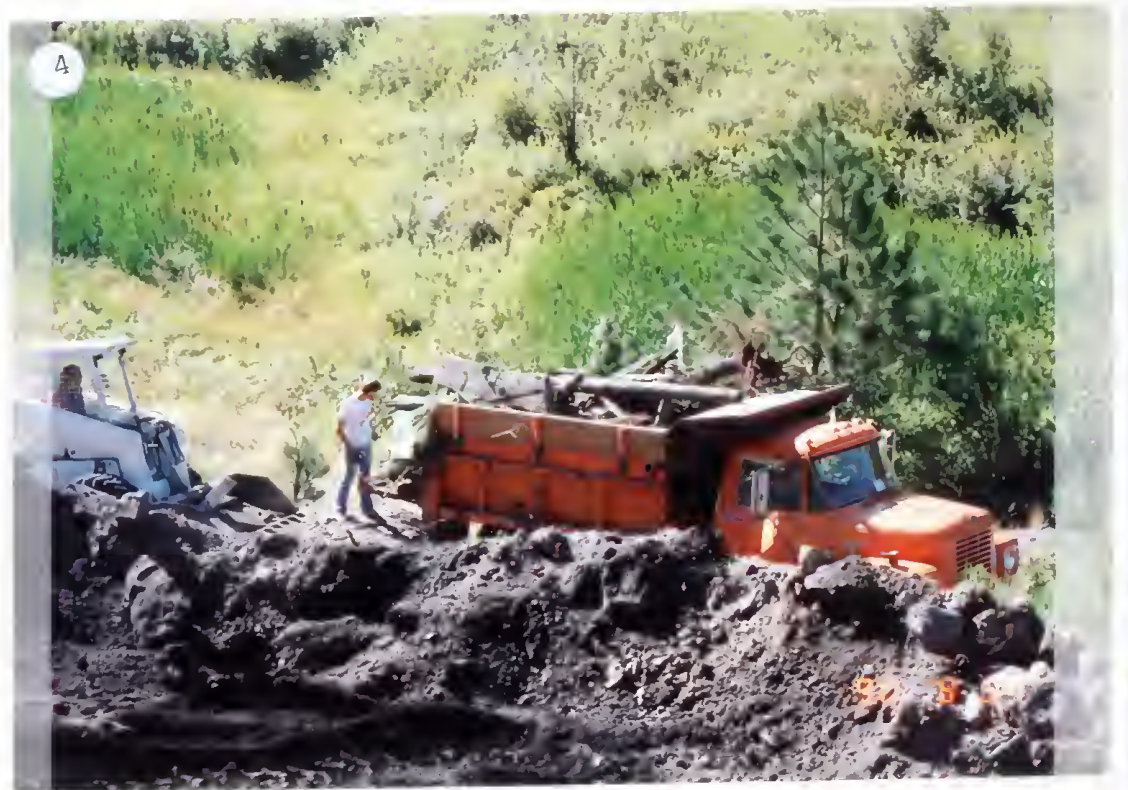
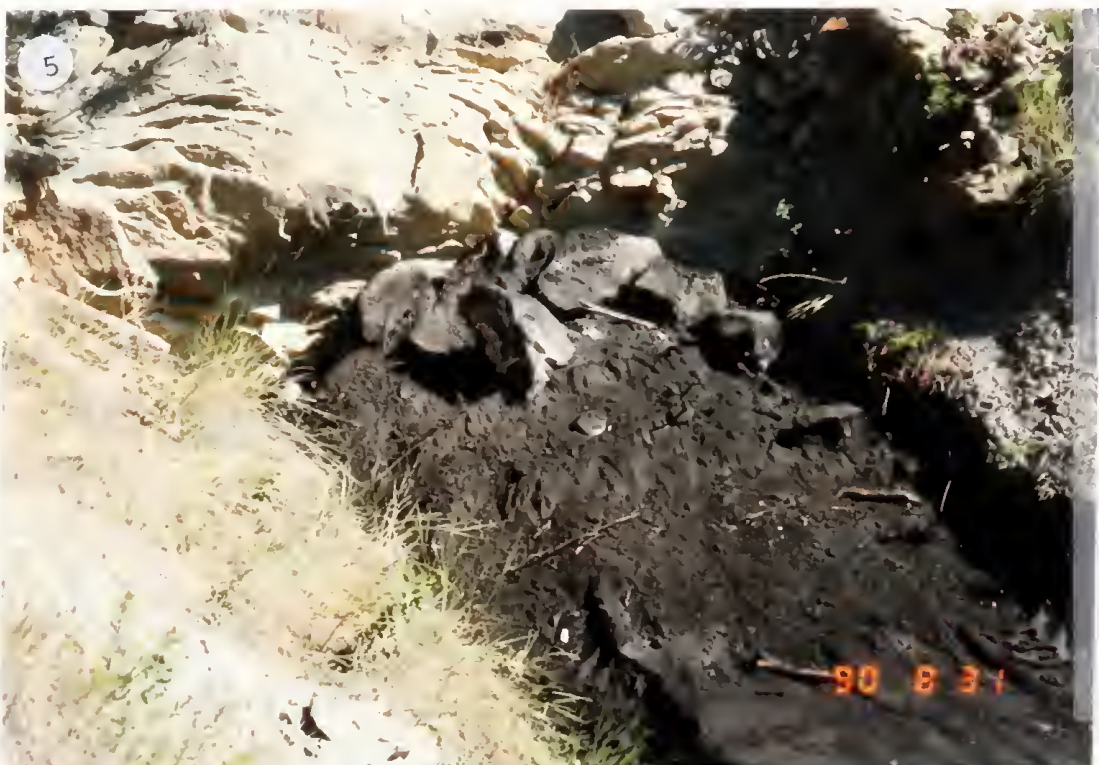
1. Benjamin Hill Mine - Adit Before Construction
2. Benjamin Hill Mine - Waste Pile Before Construction
3. Benjamin Hill Mine - Waste Pile Before Construction
4. Benjamin Hill Mine - Debris Removal
5. Benjamin Hill Mine - Adit Closure

The adit closure performed at the Ben Hill site was performed in accordance with Standard Drawing 410.01. The final contours achieved were marginal at this site. They matched the adjacent terrain, but no terracing was achieved because of equipment limitations. Due to the loose sandy nature of the coversoil used, some initial concern developed over the erosional characteristics of this material. Later investigation of compaction after moisture application showed the coversoil to have naturally compacted to an acceptable level. The straw mulch at this site was largely hand crimped and remained in place much better than was initially expected. The Engineer placed staked bales at the low end of the site to prevent coversoil erosion into Horsethief Creek.

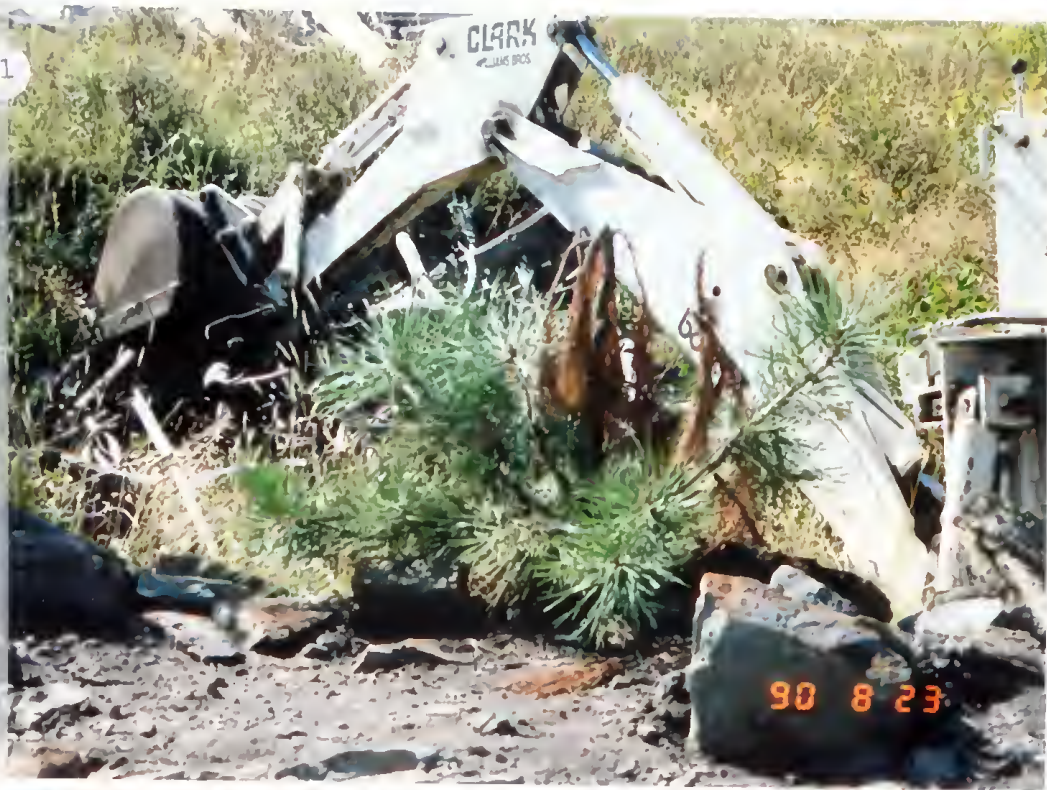
1. Benjamin Hill Mine - Low End After Reclamation
2. Benjamin Hill Mine - Site After Reclamation
3. Petersen Mines - Southeast Adit Before Closure
4. Petersen Mines - South Adit Before Closure
5. Petersen Mines - Main Prospect Before Construction

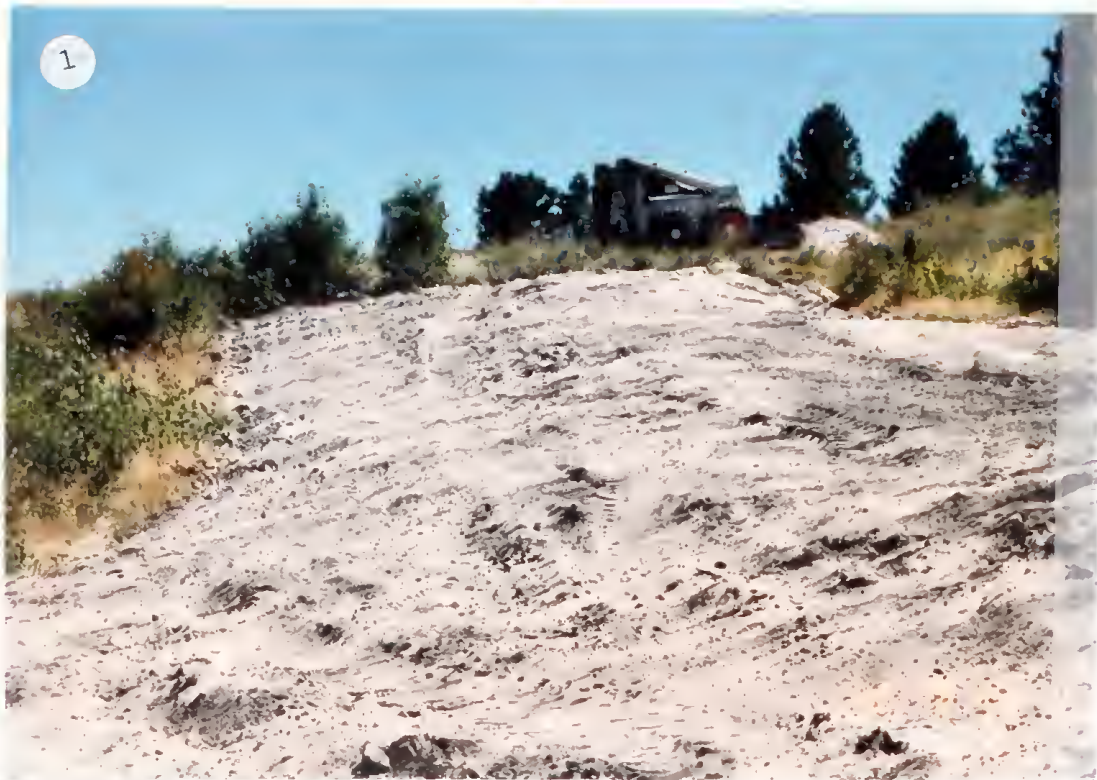
1. Petersen Mines - Main Prospect Adit Exploration
2. Petersen Mines - Main Prospect Shaft Exploration
3. Petersen Mines - East Adit During Closure
4. Petersen Mines - East Adit During Closure
5. Petersen Mines - Main Prospect Lime Exploration

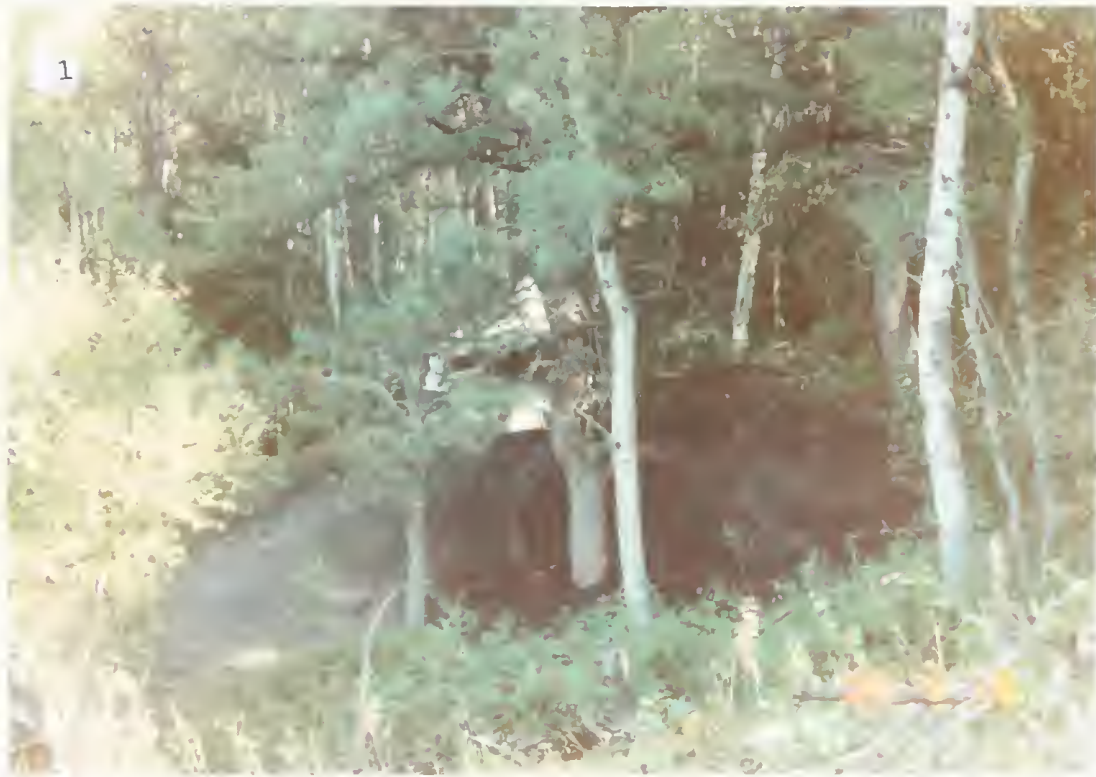
1. Petersen Mines - Main Prospect Lime Application
2. Petersen Mines - South Prospect Closed Adit
3. Petersen Mines - Southeast Prospect Closed Adit (This adit was added to the project)
4. Petersen Mines - Main Prospect Shaft Closure After Construction
5. Petersen Mines - Main Prospect After Reclamation

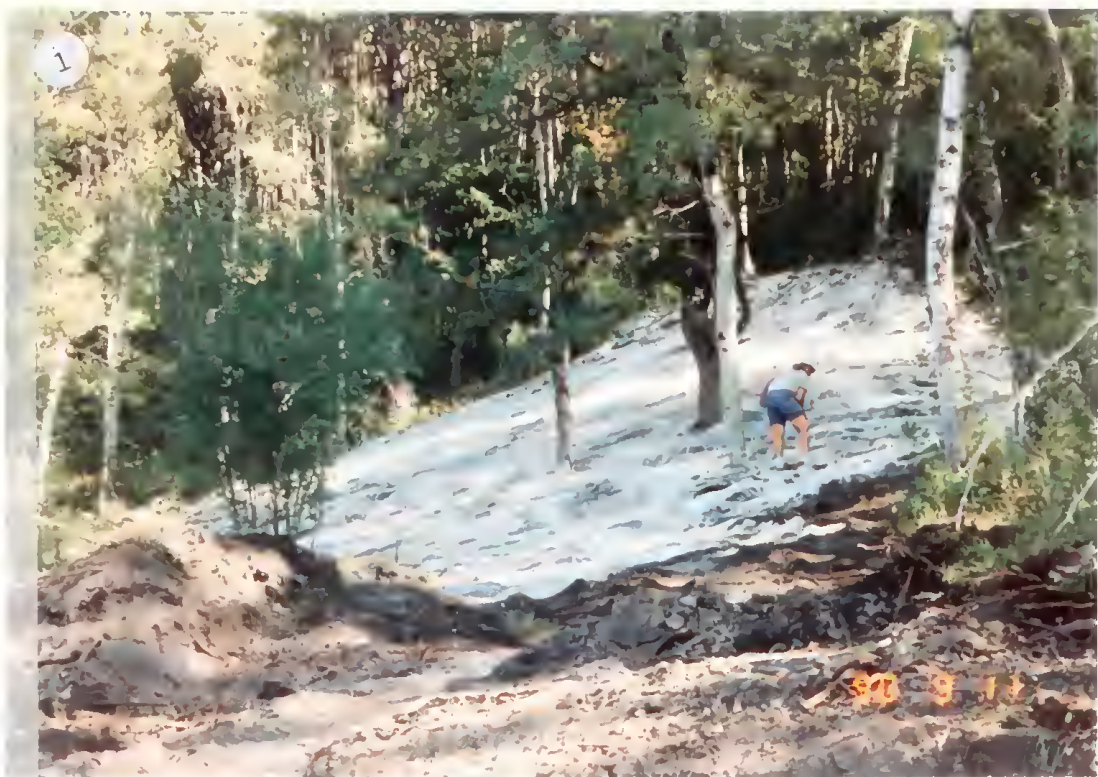
1. Frank Bland - South Prospect Beginning Construction
2. Frank Bland - South Prospect Deadfall and Brush Removal
3. Frank Bland - West Adit Before Construction
4. Frank Bland - East Adit After Construction
5. Frank Bland - West Site Coversoil Salvage

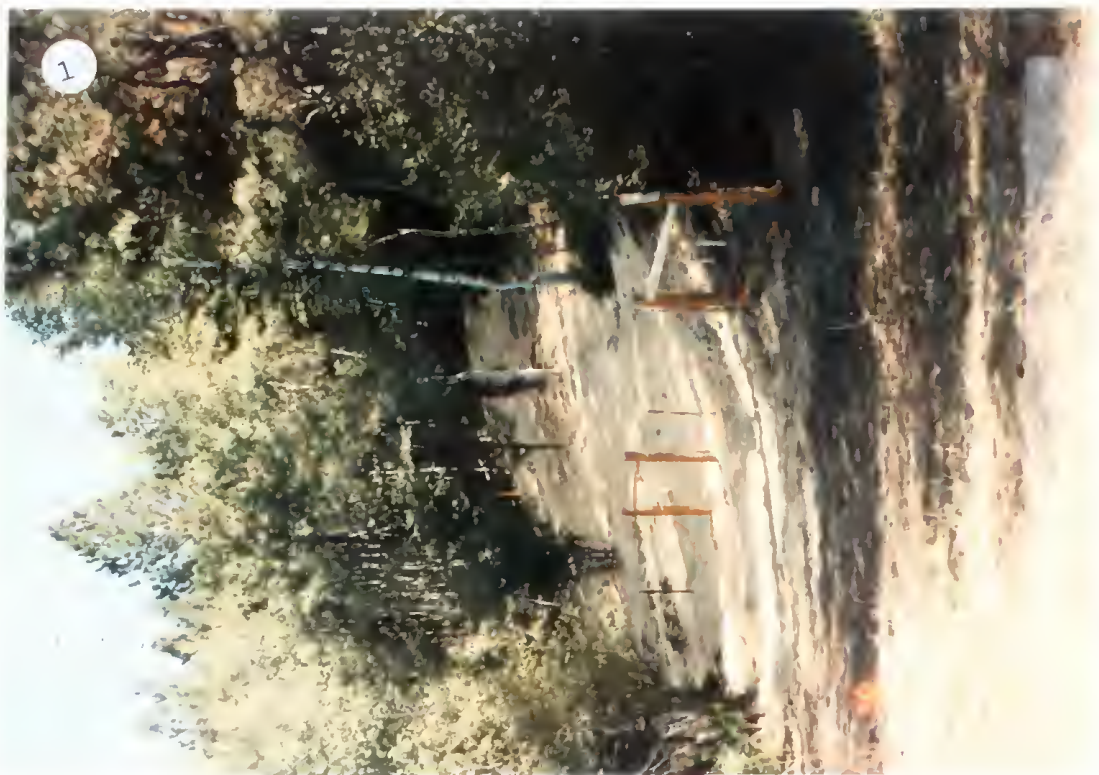
1. Frank Bland - Lime Application at South Prospect
2. Frank Bland - Straw Application at West Prospect
3. Frank Bland - South Prospect After Reclamation
4. Frank Bland - West Prospect After Reclamation
5. Frank Bland - West Prospect After Reclamation

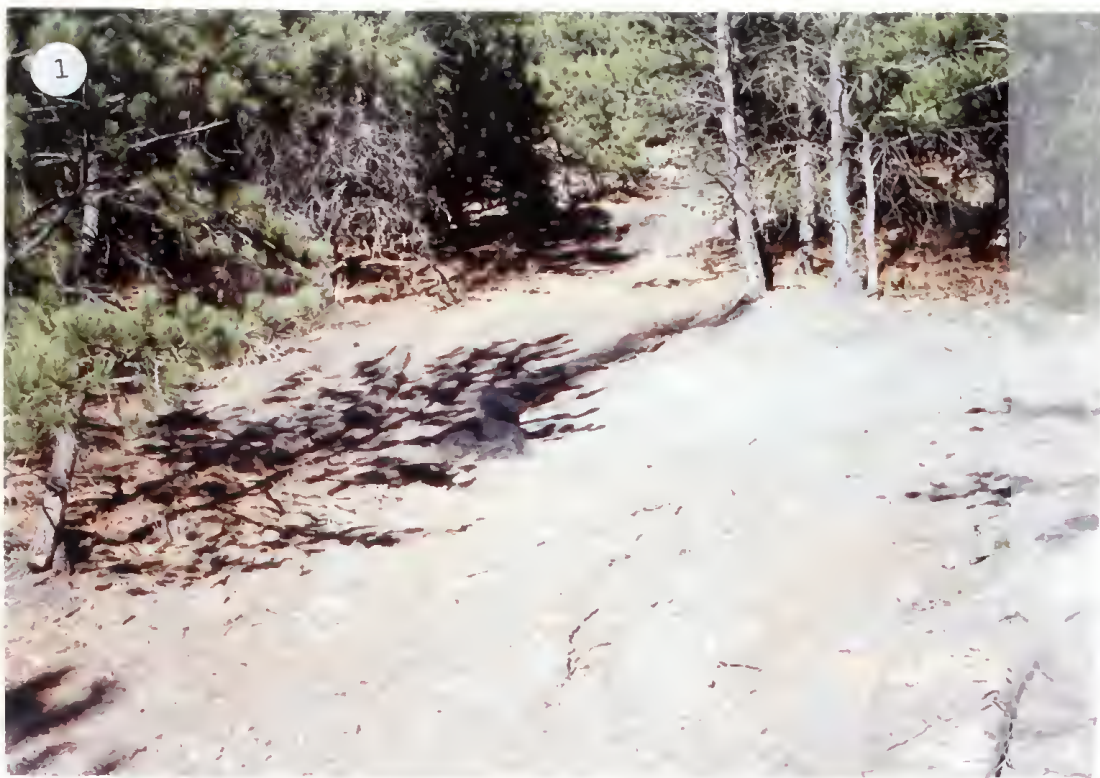
1. Swanson/Boyce - Before Construction at North Site
2. Swanson/Boyce - Before Construction at South Site
3. Swanson/Boyce - North Site at Road Before Construction
4. Swanson/Boyce - North Site Before Construction
5. Swanson/Boyce - Shaft Before Exploration

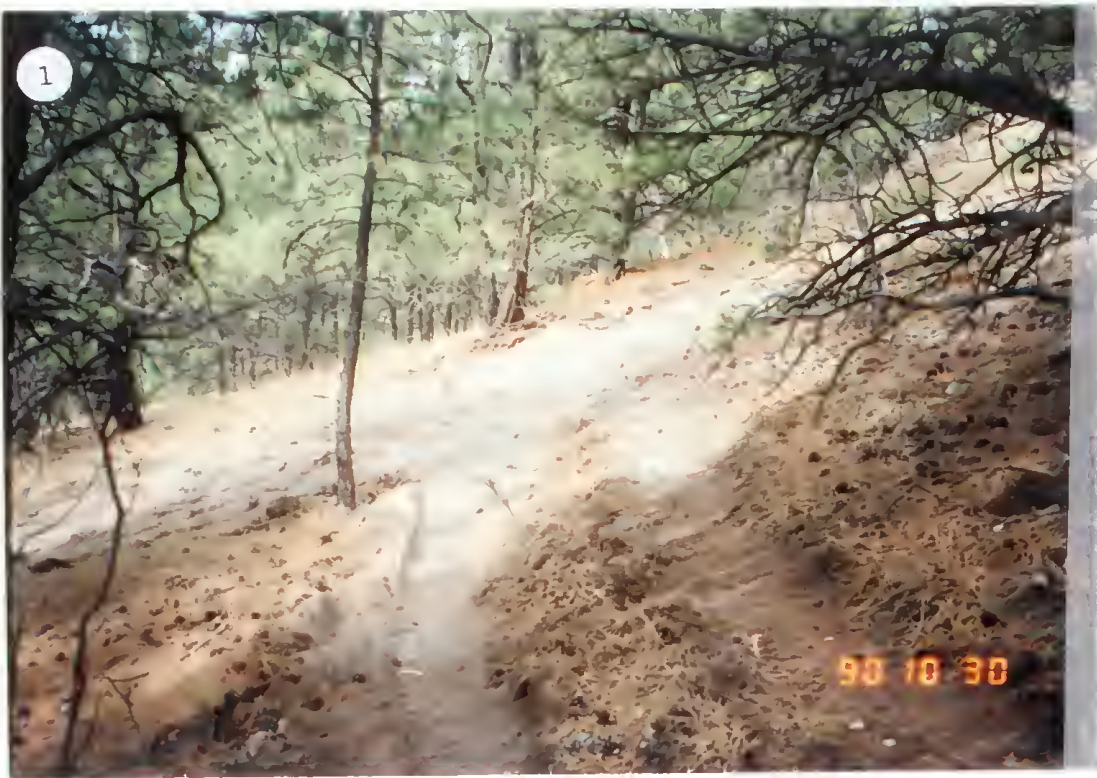
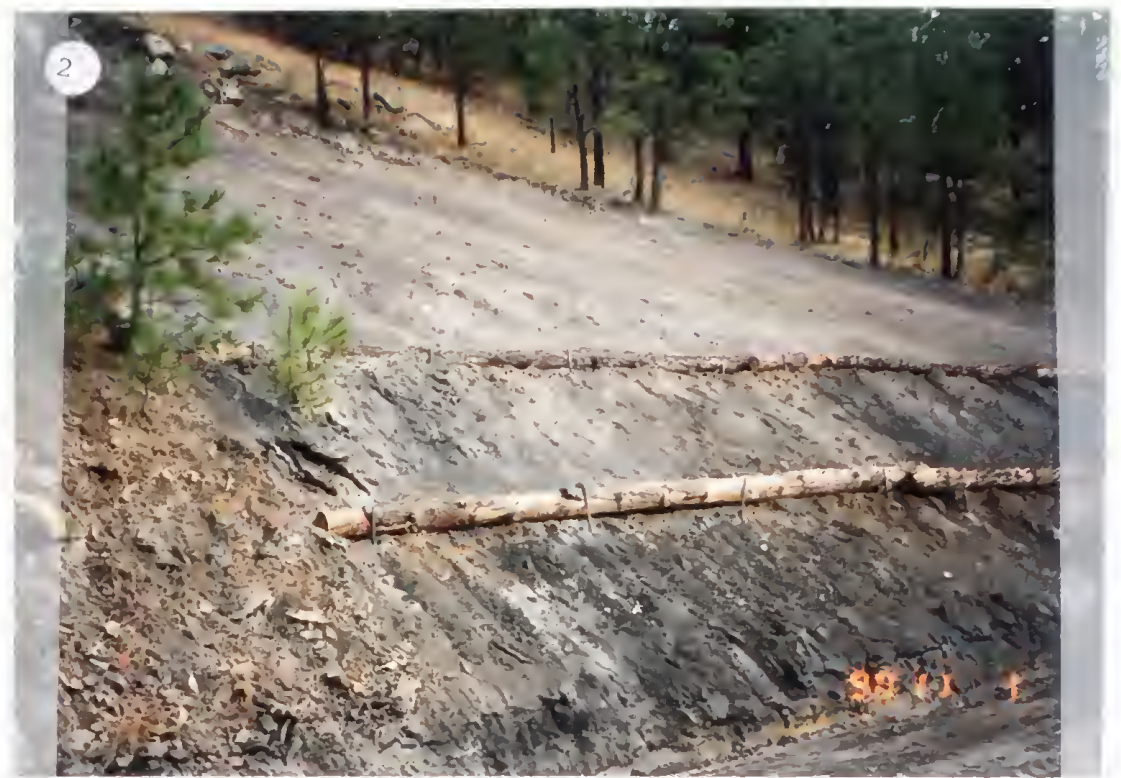
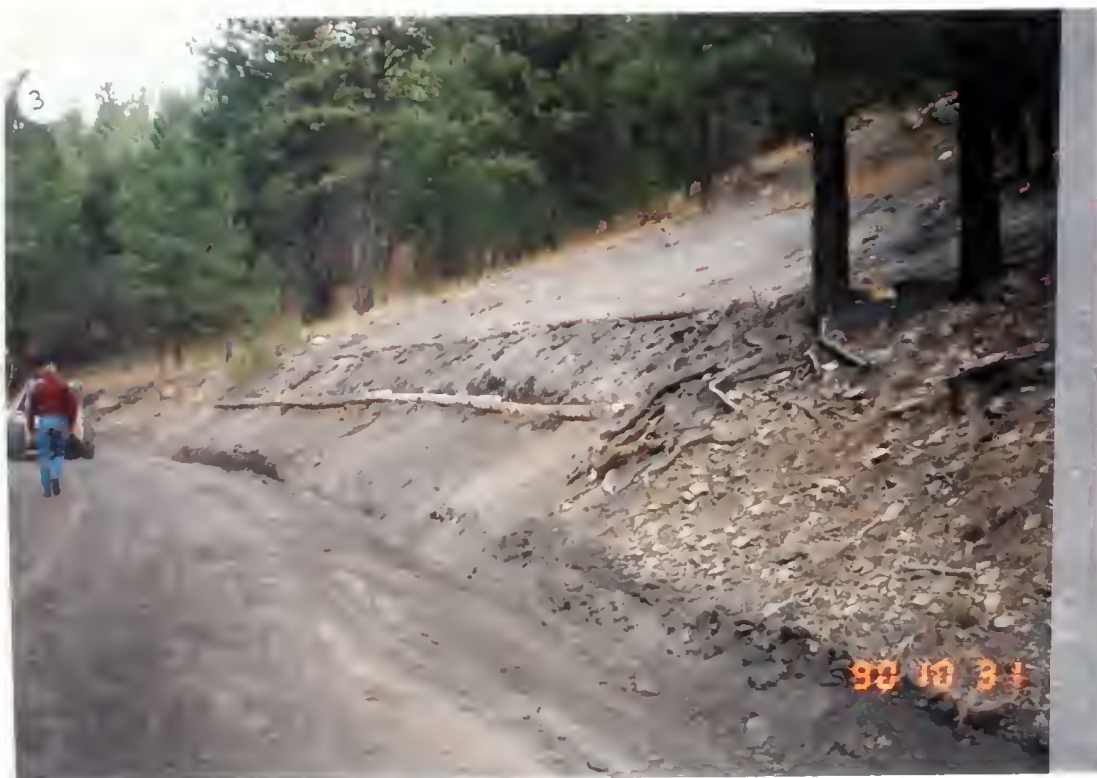
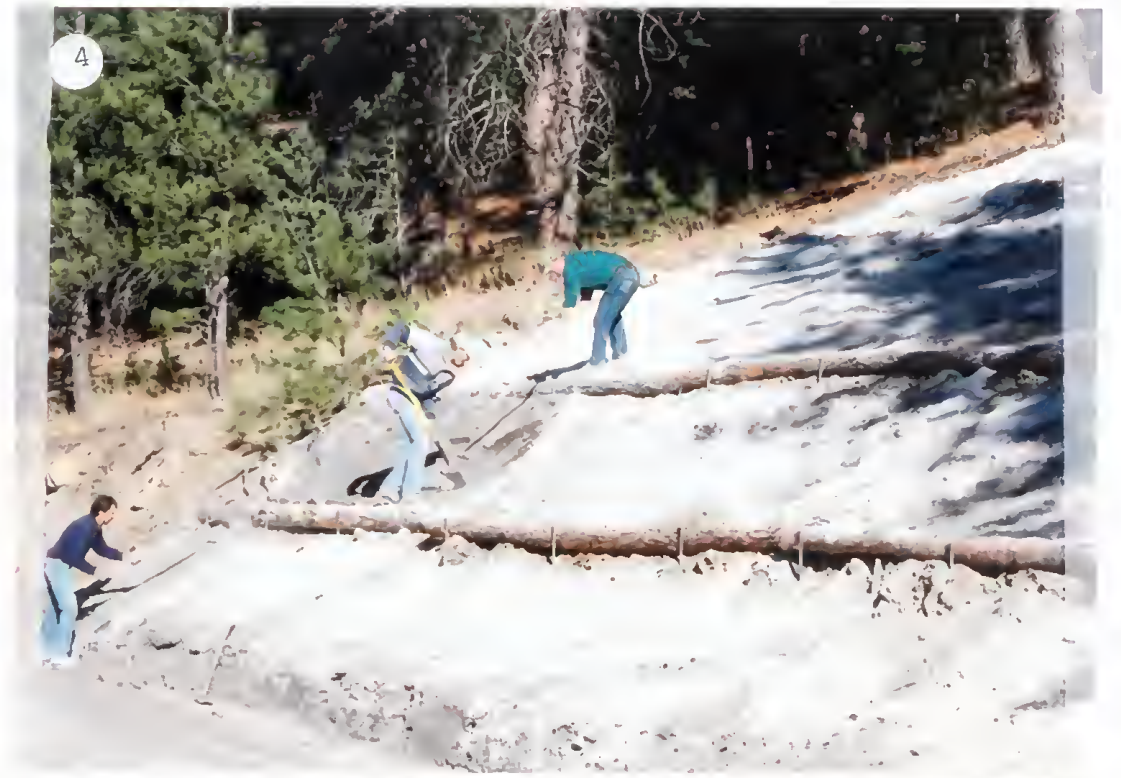
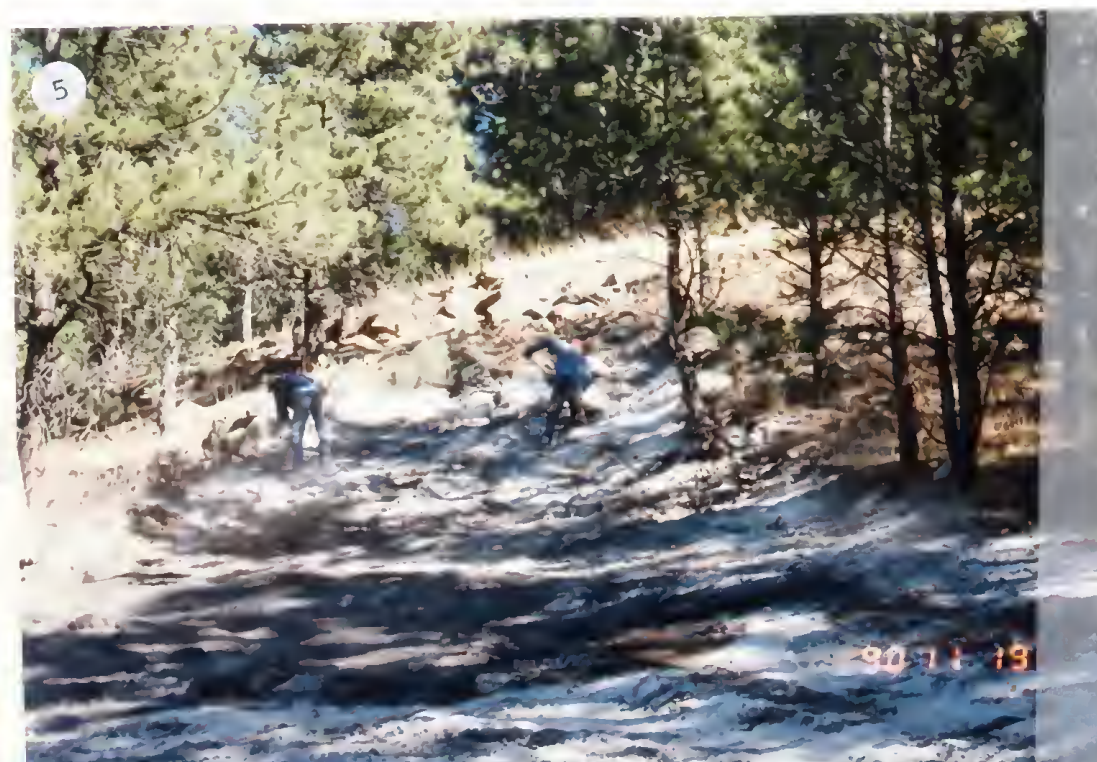
1. Swanson/Boyce - Shaft After Exploration
2. Swanson/Boyce - Beginning Shaft Closure
3. Swanson/Boyce - Adit Closure
4. Swanson/Boyce - Shaft Closure
5. Swanson/Boyce - Shaft Closure

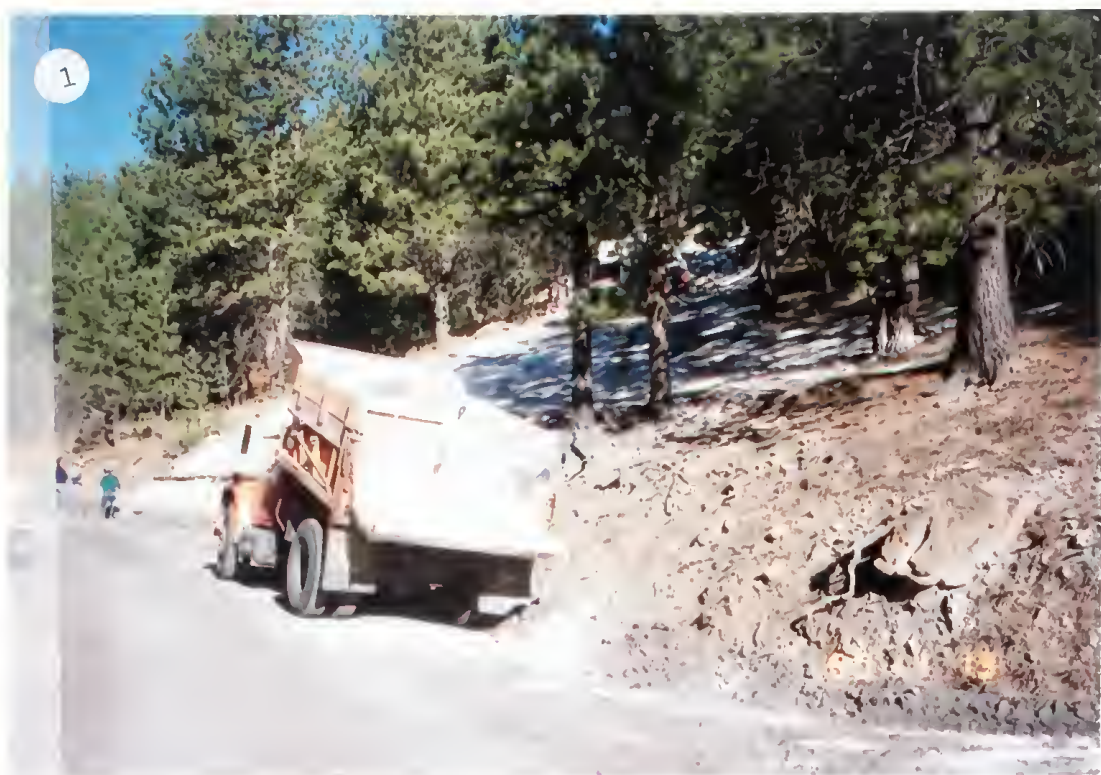
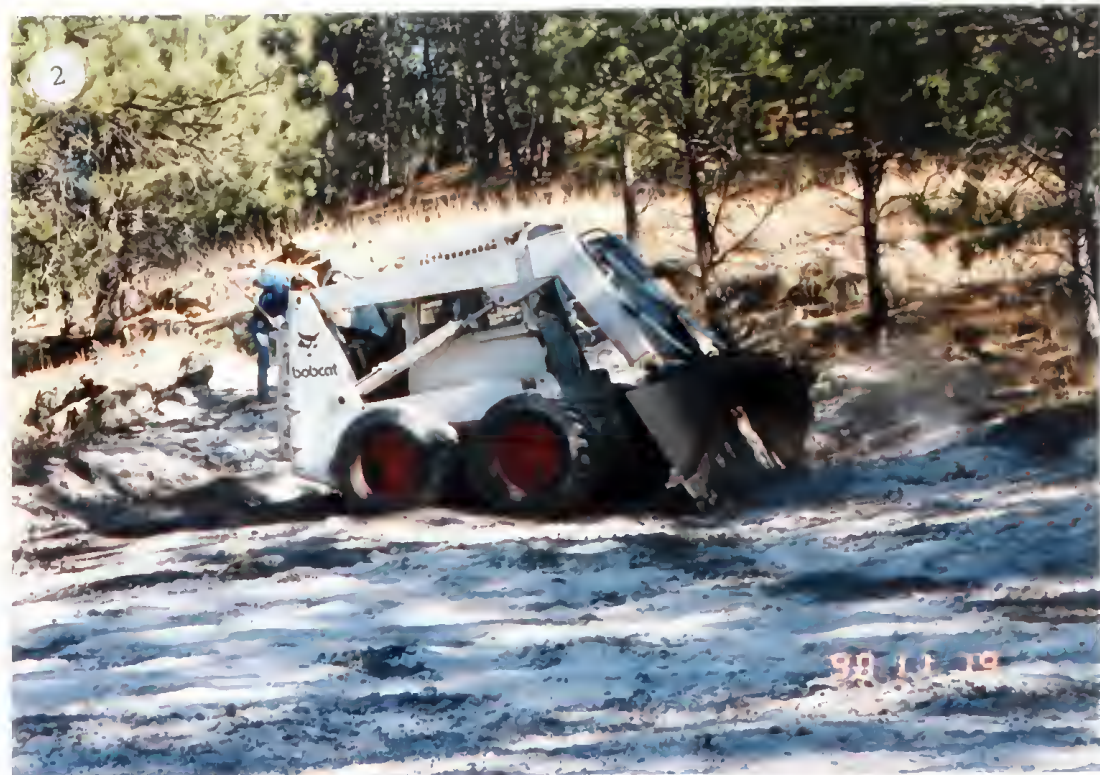
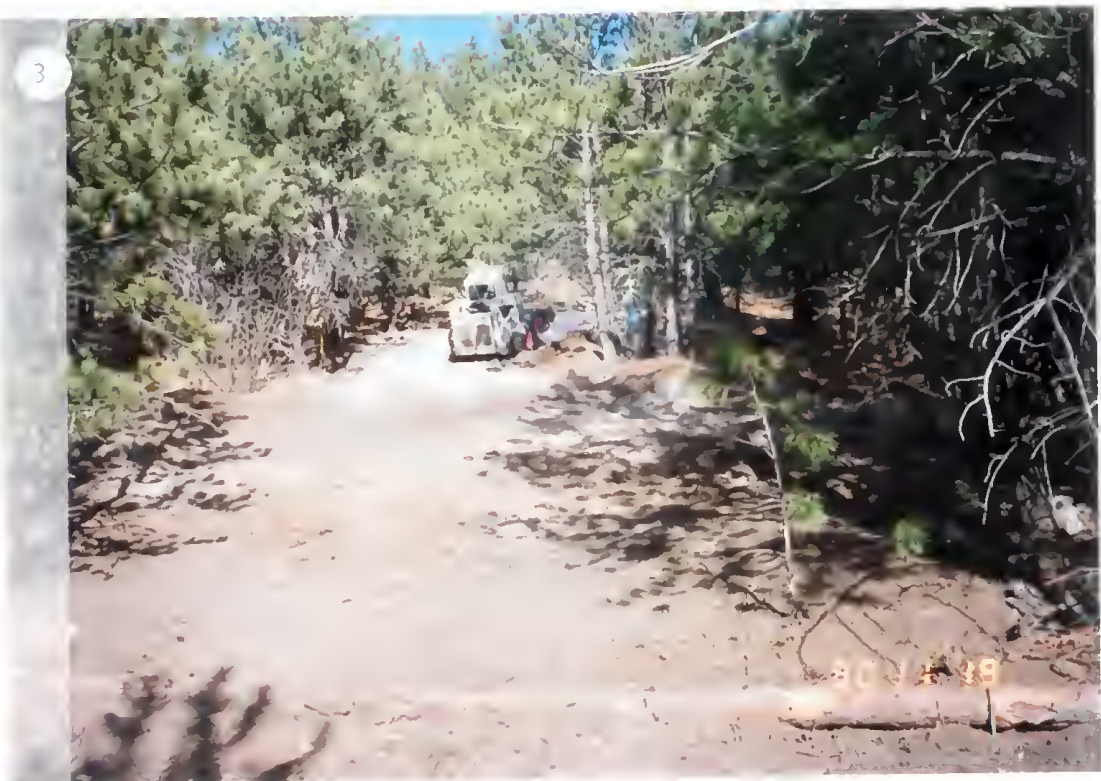
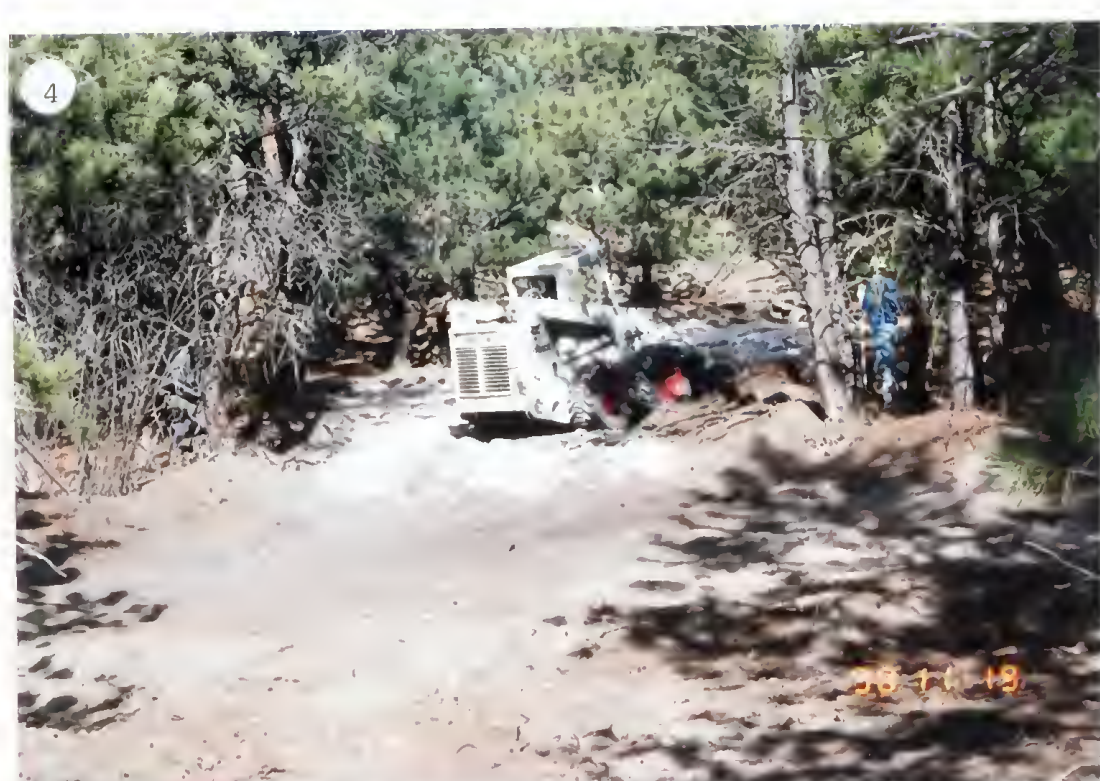
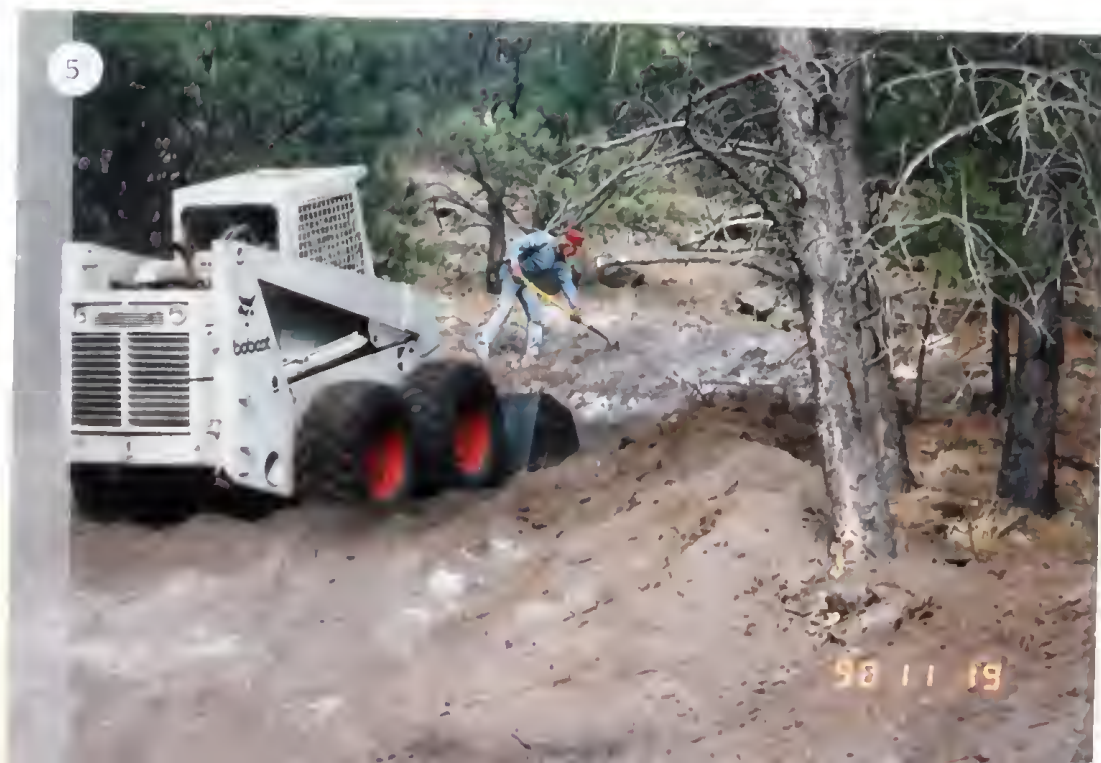
1. Swanson/Boyce - Access Disturbance
2. Swanson/Boyce - South Site Ready for Lime
3. Swanson/Boyce - South Site Log Barriers
4. Swanson/Boyce - South Site Lime Incorporation
5. Swanson/Boyce - South Site Lime Incorporation

- \* The small wheeled machinery used throughout the project provided benefits and posed problems. The machinery helped in most instances to minimize off-site disturbances. This was not the case at the Boyce/Swanson sites because switch-backs had to be installed to access the sites. Thus off-site disturbance was caused. Tracked machinery would have most likely eliminated this disturbance. The small machinery also caused scheduling difficulties for the Contractor due to break-downs and increased operating time because of payload capabilities.
